PAVEMENT EVALUATION
CALLE OSAY BO-OH
PASCUA YAQUI INDIAN RESERVATION
PIMA COUNTY, ARIZONA

PROJECT # 110048

Prepared by:
ATEK Engineering Consultants, LLC
111 South Weber Drive, Suite 1
Chandler, Arizona 85226

July 15, 2013

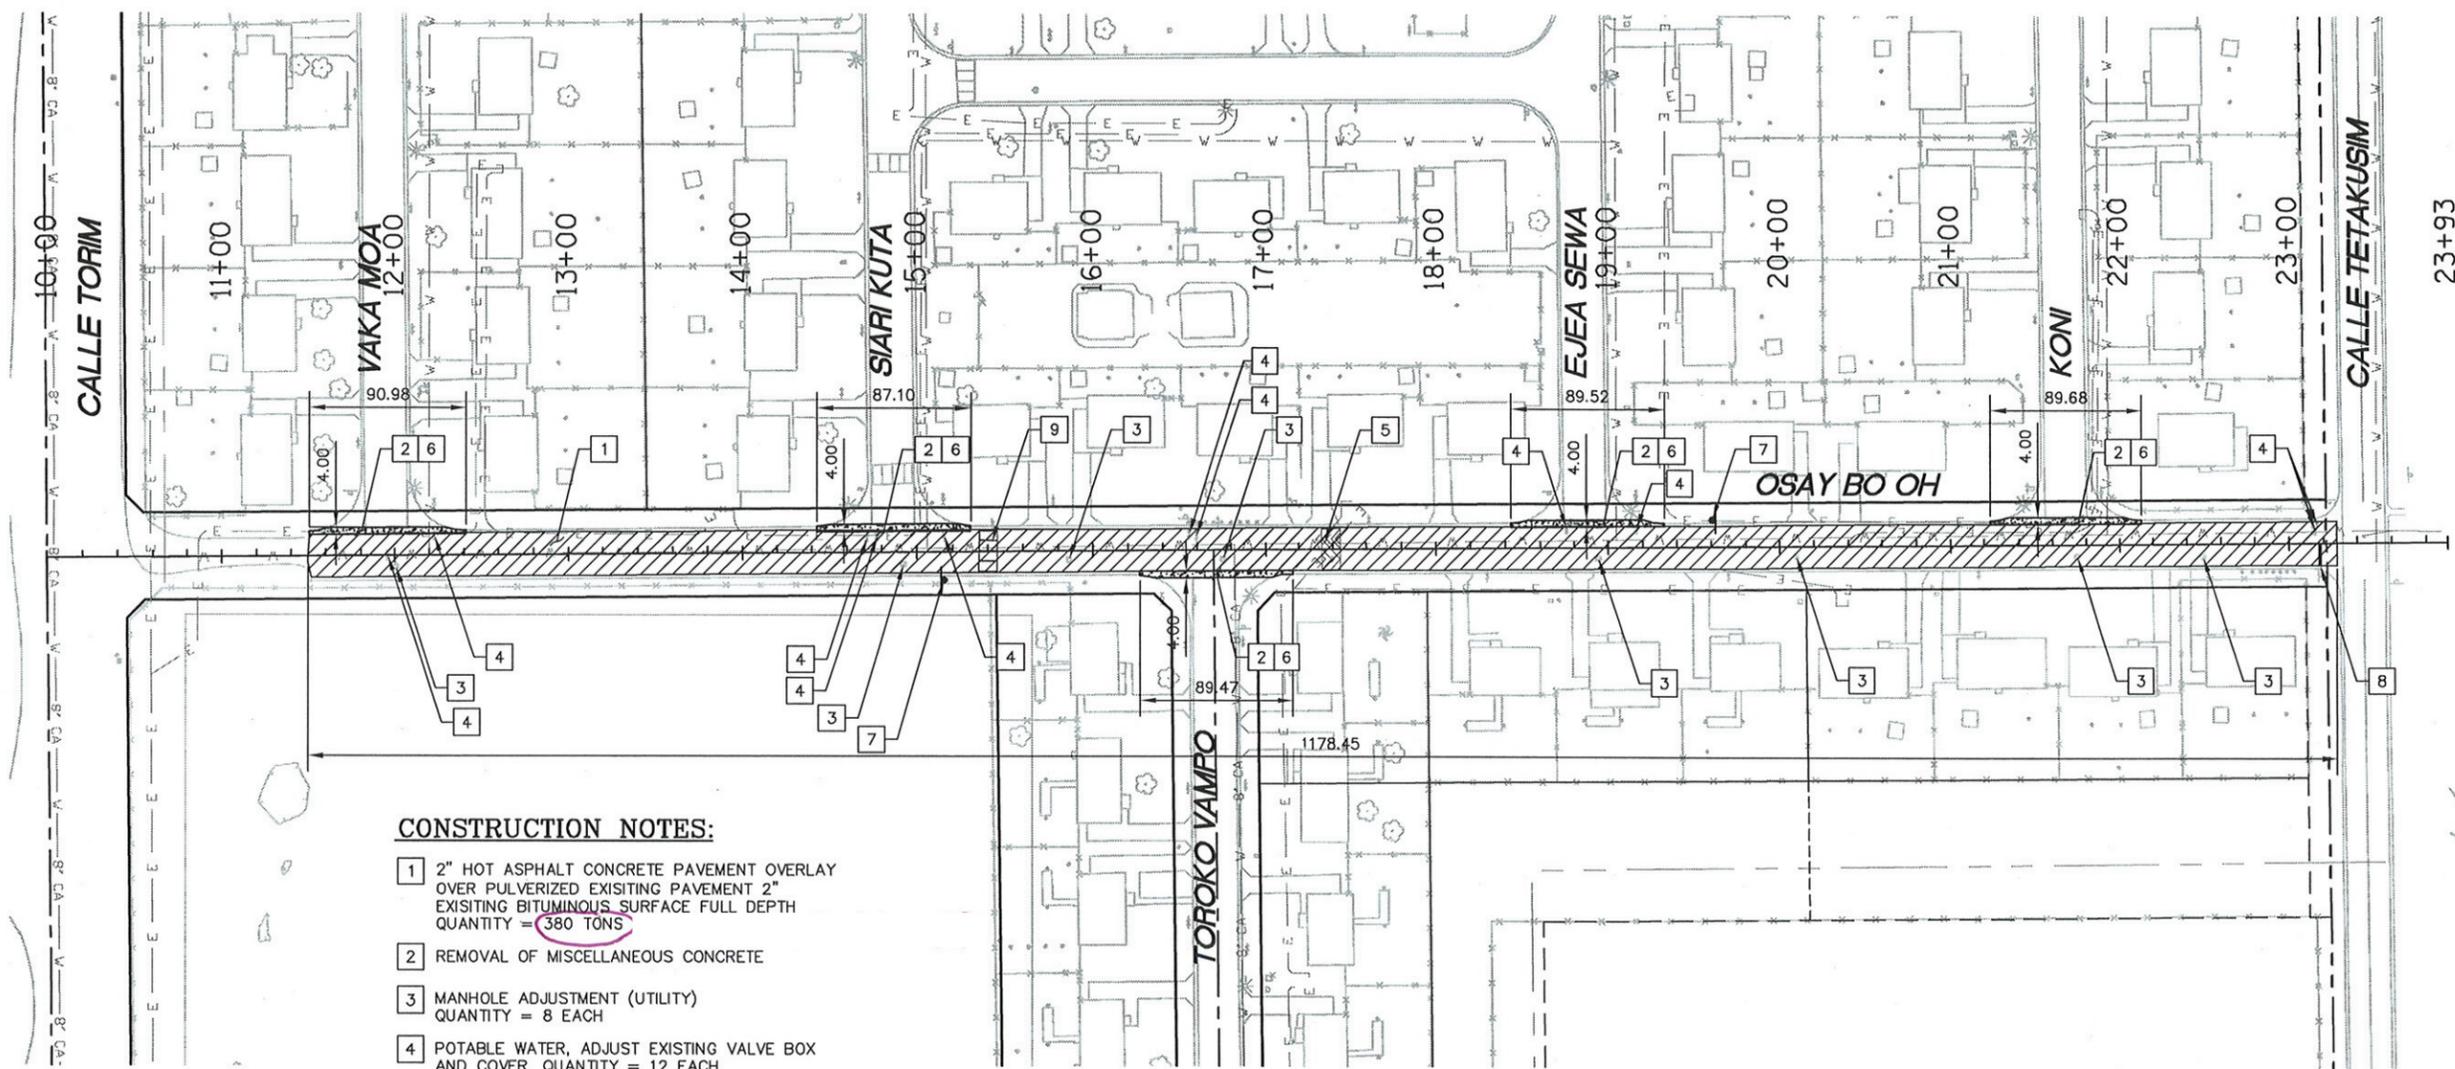
PROJECT PLAN MAP

CONSTRUCTION NOTES:

- 1 2" HOT ASPHALT CONCRETE PAVEMENT OVERLAY OVER PULVERIZED EXISTING PAVEMENT 2" EXISTING BITUMINOUS SURFACE FULL DEPTH QUANTITY = 380 TONS
- 2 REMOVAL OF MISCELLANEOUS CONCRETE
- 3 MANHOLE ADJUSTMENT (UTILITY) QUANTITY = 8 EACH
- 4 POTABLE WATER, ADJUST EXISTING VALVE BOX AND COVER, QUANTITY = 12 EACH
- 5 NEW SPEED HUMP PER DETAIL SHOWN IN SHEET 5 THIS PLAN SET
- 6 CONCRETE VALLEY GUTTER PER PCDOT/COT STD. DET. 208 QUANTITY = 1667 SF
- 7 NEW SIGN POST AND SIGN PANEL (W17-1, W13-1 [15 MPH])
- 8 NEW STOP BAR STRIPING (18" SOLID WHITE, HOT SPRAYED THERMOPLASTIC)
- 9 NEW CROSSWALK STRIPING (12" SOLID WHITE INCREMENTS) PER DETAIL SHOWN IN SHEET 6 THIS PLAN SET
